## Assessment – Post-Trip Report

<b>Community:</b>	El Cacao
<b>Country:</b>	Nicaragua
<b>Chapter:</b>	University of Maryland
<b>Submittal Date:</b>	
<b>Dates Traveled:</b>	January 14, 2018-January 22, 2018
<b>Authors:</b>	Heather Groves, Nipun Kottage, Bryan Croce, Nina Horne, James Baldwin, Taqui Mahmood
<b>Scope of Assessment (100 words)</b>	To determine needs of the community; to map out houses, latrines, and all existing infrastructure; to test soil and water quality; and to assess the barriers (or lack of) created by local governmental agencies.

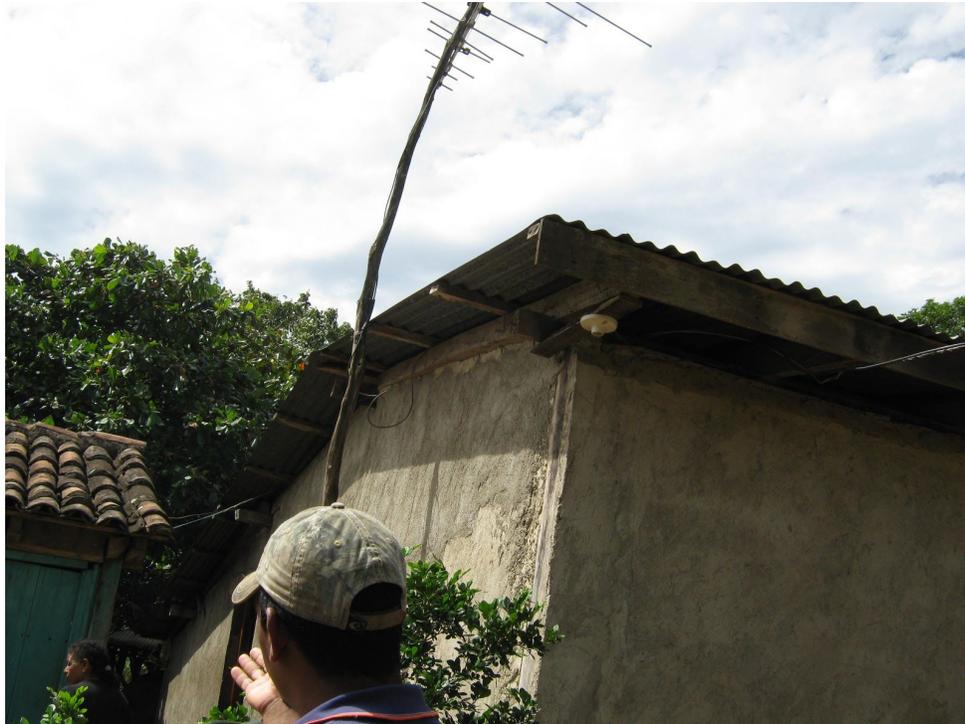
In addition to these organization meetings, we also visited nearby communities to see how they have implemented their water systems. We visited a private farm outside of Santa Teresa, where we looked at a 12m deep well that has been there for 80 years. The owner uses a rainwater roof catchment using bent sheet metal and PVC to run off to a tank during the dry season. He pumps the water to a smaller reservoir using his electricity for drip-irrigation. We also visited Cruz Verde, a similar though slightly more compact community, and talked with their CAPS president and took a look at their pump site and storage tank. Cruz Verde uses a pay based on income system, and people get water pumped to their house to store in tanks every fourth day.

*Figure 5: Rainwater roof catchment system at the farm*

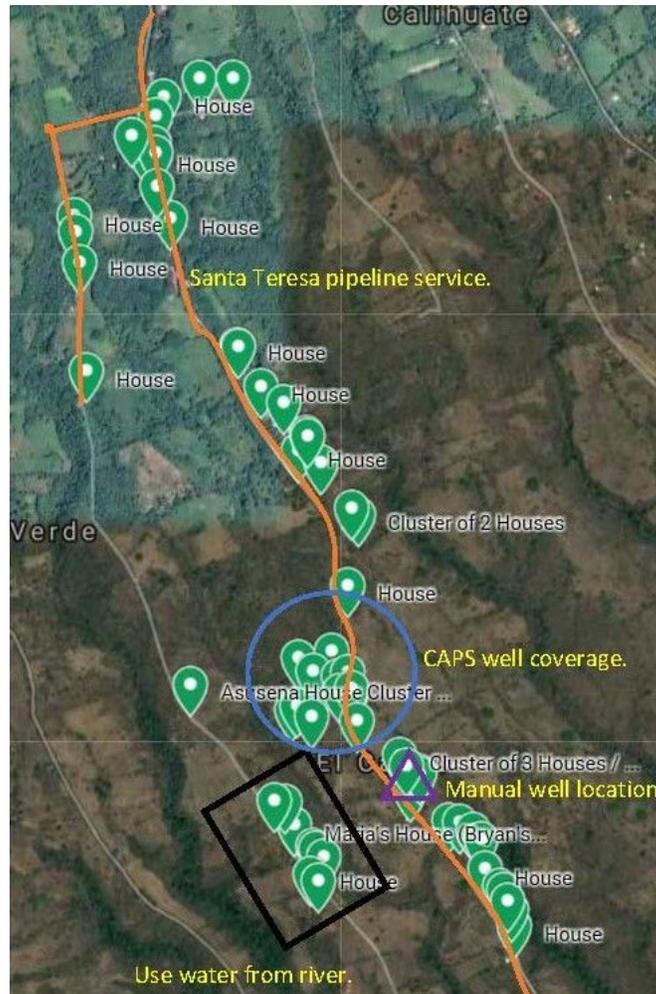
El Cacao is divided geographically into two roads (main and western branch). The main road contains three service areas created by ENACAL, north, central, and south. The central service area is further divided into north-central and south-central at the school by EWB-UMD. The western branch clusters into northern and southern sets of houses.

Figure 7: A map of El Cacao showing the water sources who it services.

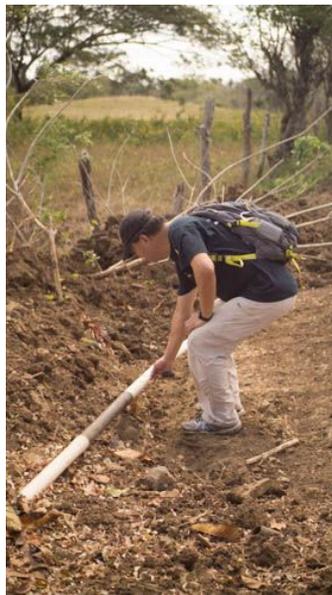
Piped water is supplied to el Cacao from Santa Teresa and the CAPS well. *Aqua potable* managed by ENACAL is piped to the rural communities of El Cacao and El Sol from Santa Teresa. Due to water scarcity, both communities receive water from this system once or twice every eight days, on rotation. ENACAL controls a set of valves which are opened for half an hour to an hour at arbitrary times to provide water to the communities. The community of Cruz Verde once received water from this utility until USAID implemented a water system for the community.

*Figure 8: An exposed portion of the water line.*

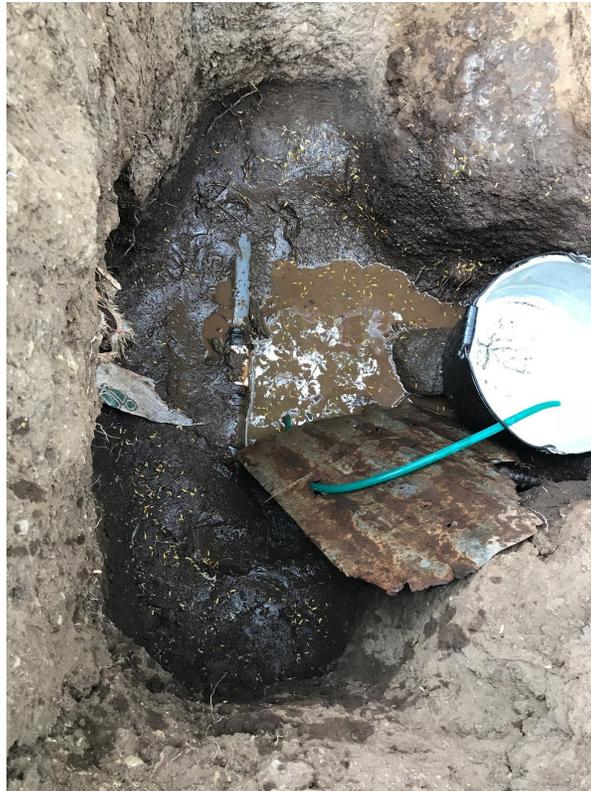
Water is transported via a piped distribution system to each community. In El Cacao, this system consists of a 2" diameter main line which follows the main road (Figure 7). This line branches to include houses along [name] road. Water is piped to the 60-65 houses in the community which receive this service. Water is accessed at each house through an outdoor spigot. It was noted that several of these spigots have been removed due to low water pressure (Figure 9). ENACAL partially maintains this system by infrequently repairing damages to the line. A walk of the system revealed several leaks and major failures (See Appendix E). Claudia reports that the majority of repairs are conducted by community members.

*Figure 9: Water pipe access through a hose instead of spigot due to lack of pressure.*

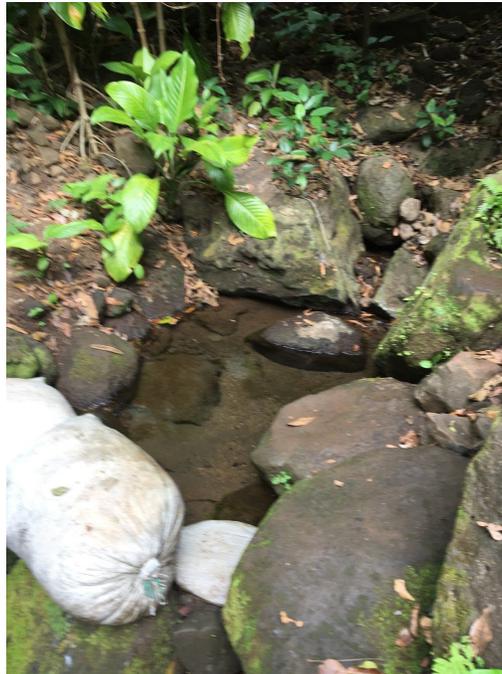
The river is accessed at a head spring on the southwest boundary of the community. Most community members utilize the spring in dry months for bathing, washing clothes, and recreation. People typically collect water close the spring and conduct other activities downstream. The river is accessed by a descending trail for about 15-20 m, composed of primarily packed earth. Several families clustered near the river (Western-branch, south) utilize the spring as their primary water source. One family conducts 12, thirty-minute round trips, with 2 jerry cans per trip, per day to collect water.

*Figure 10: The spring in the Southwest corner of the map. The sandbagged area is the primary collection site.*

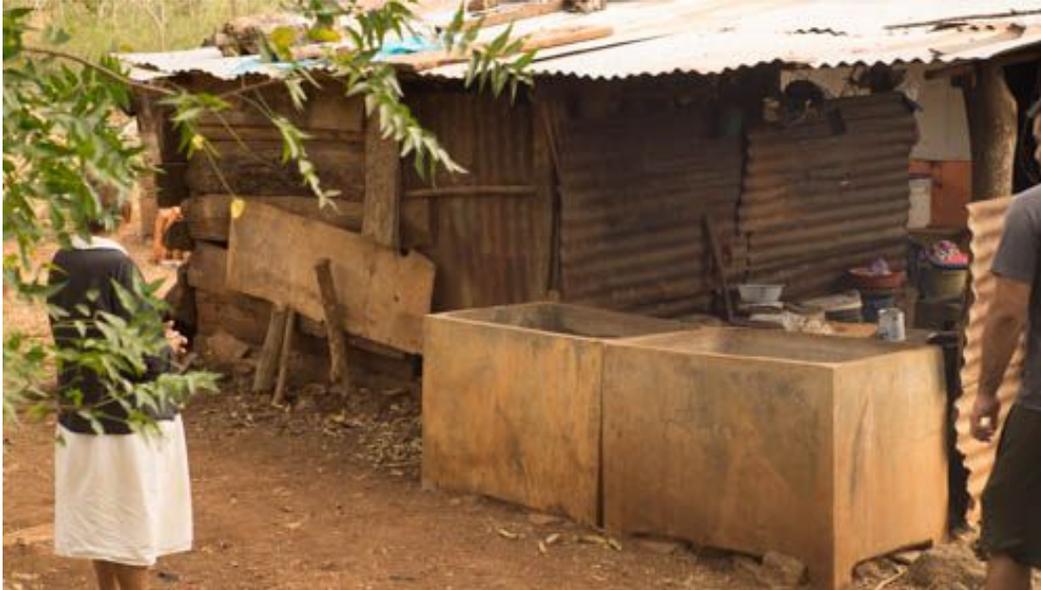
One small-scale agricultural user was interviewed. The man reports that he earns an income by selling crops in nearby markets. He utilizes water from the CAPS well and a rainwater collection system stored in a 100-400 L pila to water his crops. The scale of agriculture in the community ranges from families with individual small gardens to farmers with commercial agriculture. From the water storage containers that we viewed, there was a range in amounts of water that each of the families are using.

*Figure 11: Two concrete pilas next to each other for water storage.*

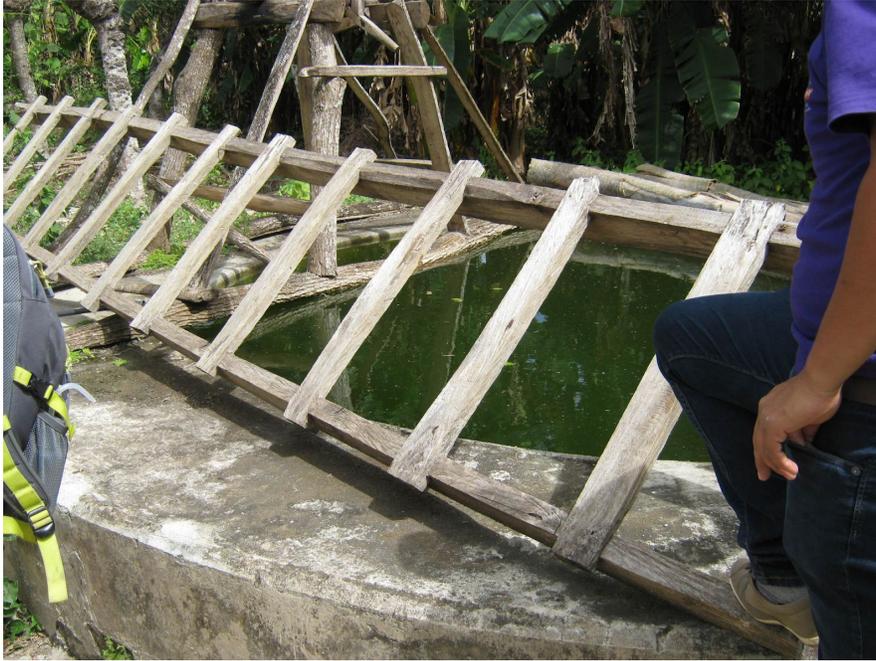
We visited a private farm outside of Santa Teresa, where we looked at a 12m deep well that has been there for 80 years. The owner uses a rainwater roof catchment using bent sheet metal and PVC to run off to a tank during the dry season. He placed concrete on the slight incline next to his tank so that when it rains, the water doesn't soak into the ground and instead goes into his tank. He pumps the water to a smaller reservoir using his electricity for drip-irrigation. He also has a biogas system using cow and horse waste to generate gas that he uses in his kitchen. It also generates manure to be used in his fields.

*Figure 12: Santa Teresa Farm Well*

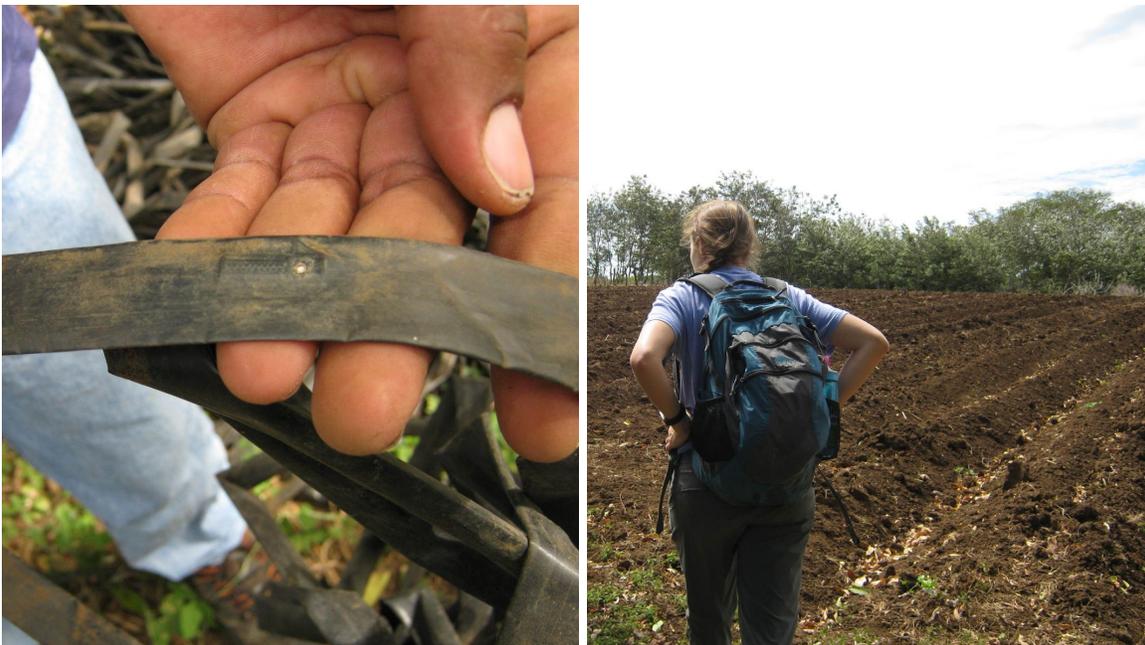
*Figures 12 and 14: Santa Teresa Farm Drip Irrigation Tube and Farm*

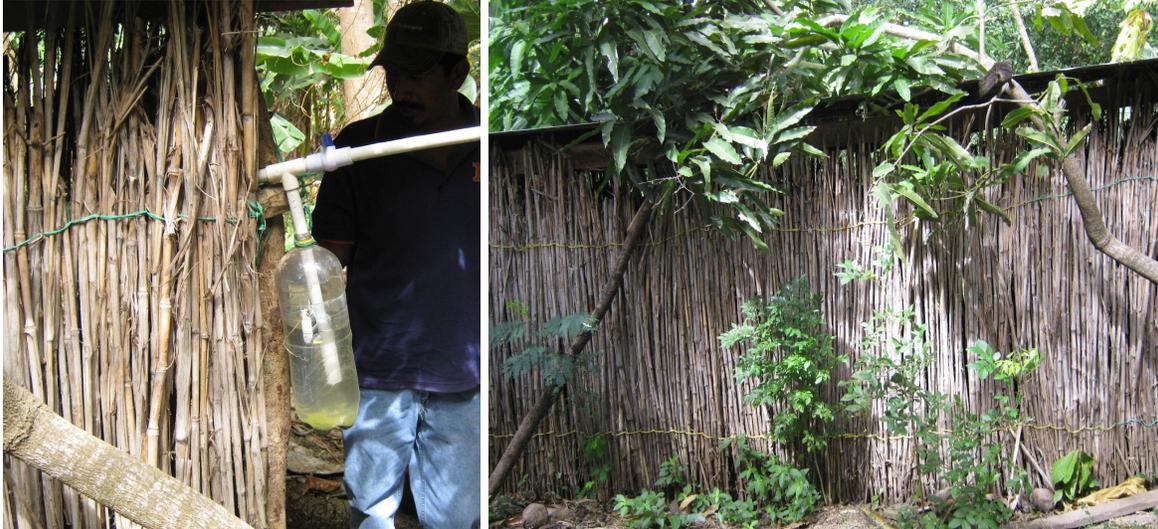
*Figures 15 and 16: Santa Teresa Farm Biogas System*

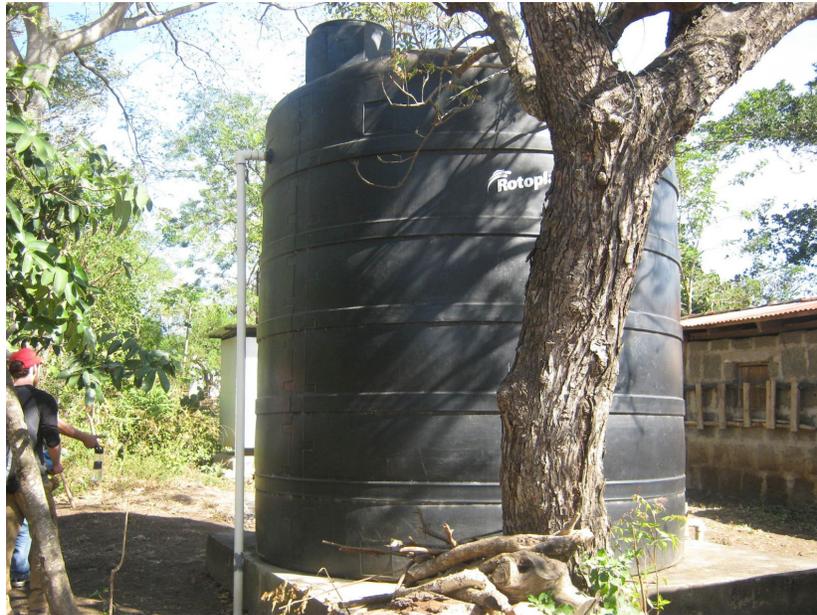
We visited Cruz Verde, a similar community with about 60 households, and talked with their CAPS president and took a look at their pump site and storage tank. Cruz Verde uses a pay based on income system, paying between 80-200 cordoba, averaging to about 150 cordoba per household. This equates to collecting 9000 cordoba per month as a community, paying 8000 cordoba for electricity per month and keeping 1000 cordoba for maintenance. They pay Ignacio Lopez 3000 cordoba to maintain their system every 6 months. Some community members use ceramic filters from San Marco, which cost \$12 and are replaced every two years. Their well cost around \$30,000, put in by USAID. The distribution reaches every household, which is simpler for Cruz Verde than El Cacao because it is a more compact community. People get water pumped to their house to store in tanks every fourth day.

*Figure 17: Cruz Verde Tank*

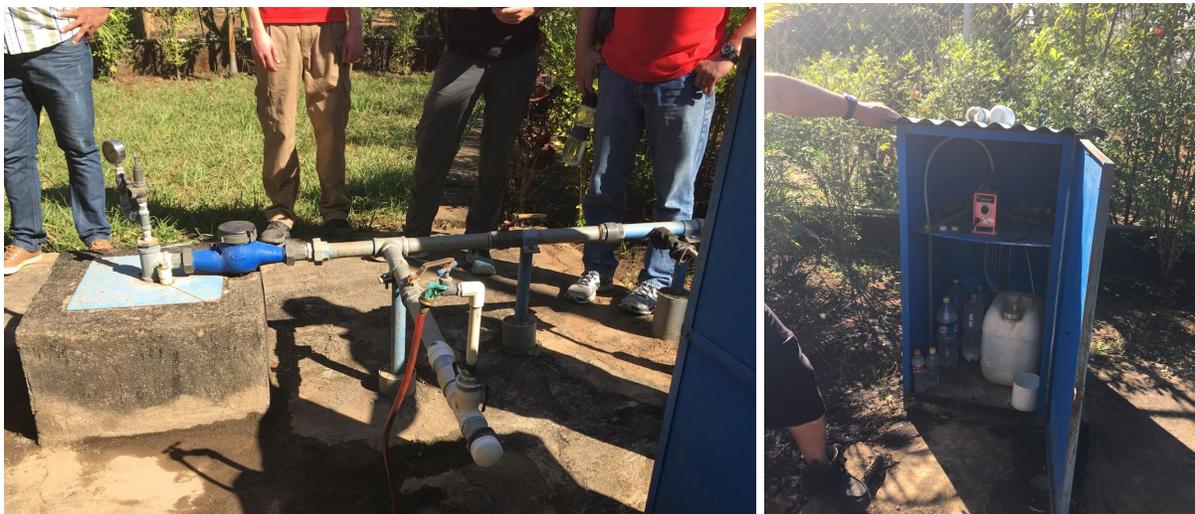
*Figures 18 and 19: Cruz Verde Water System*

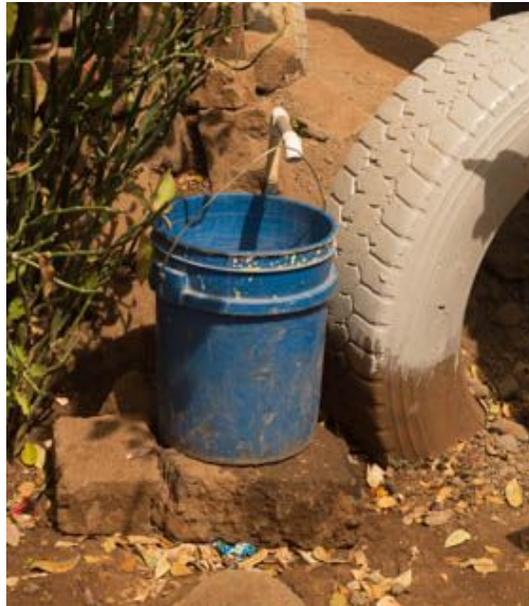
*Figure 20: An example of the taps used to deliver water to the individual homes.*

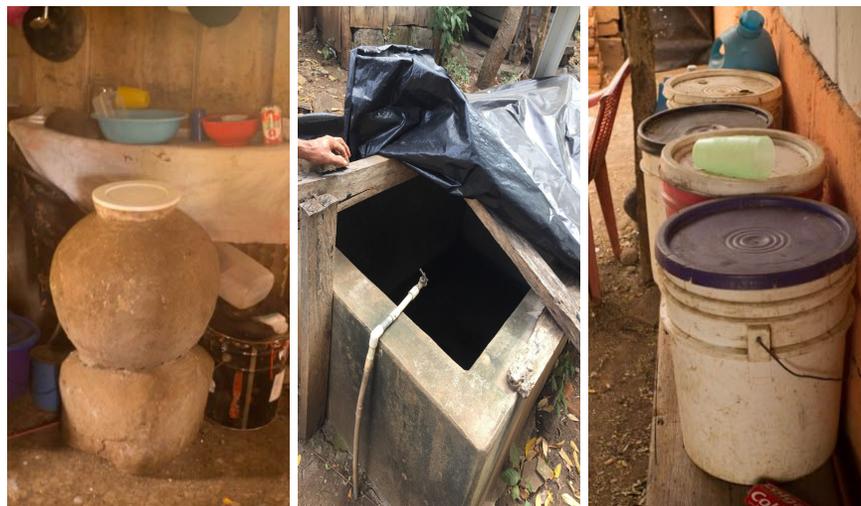
*Figure 21: From left to right clay pots, a pila and plastic 20 gallon water containers. The 20 gallon water containers are often also used to carry water from the tap location or the stream (if water is collected from there for that household).*

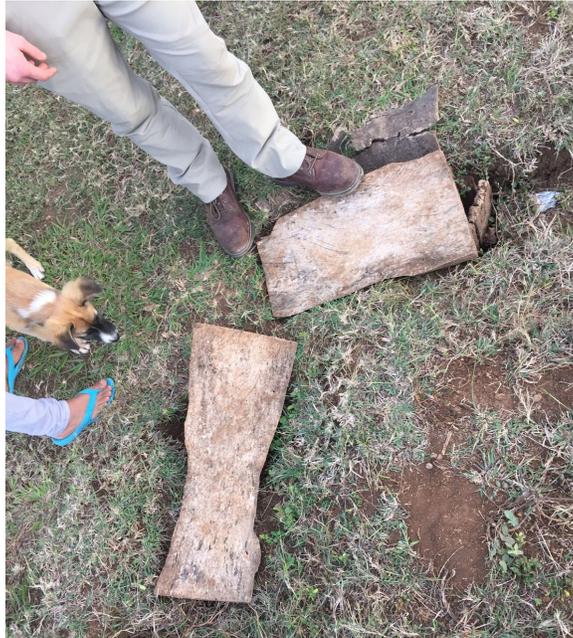
*Figure 22: The cover of the valves used to direct water to the different areas of the community from the CAPS well.*

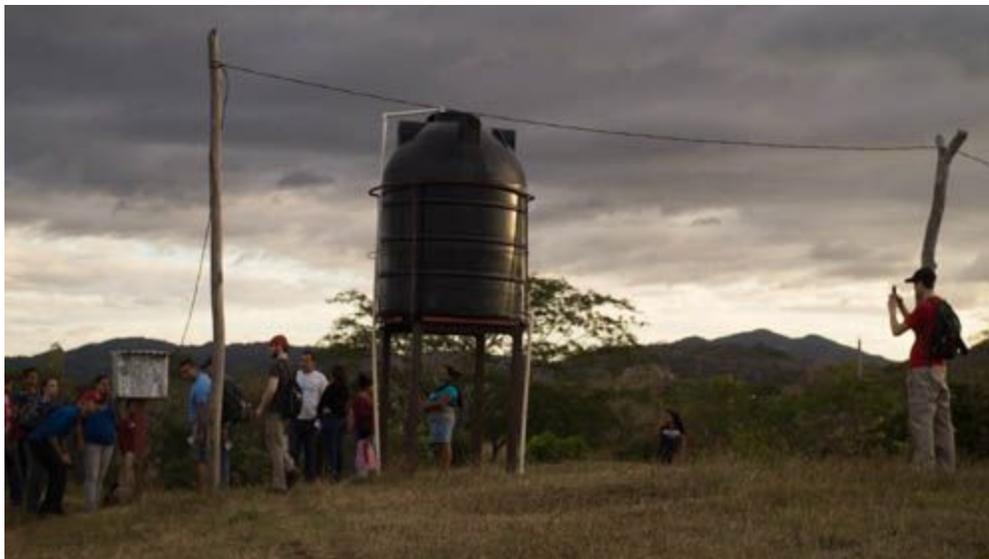
The CAPS well is also a superficial well. It has been finished and sealed with concrete and outfitted with a submersible pump. Originally, the well had been hand dug by the community but ran dry. Community members contributed to deepening the well until it provided water once again. An organization called the Fundacion Cristianos Nicaraguenses por los Pobres aided the community in mechanizing the well with a pump connected to the electric community line. A report received from the EWB field office said the well was hand dug to a depth of 45 meters and the water level fluctuates between 2-3 meters. The pump powering the system was a 1.5 hp pump with an estimated flow rate of 5.5 gpm was included. A 5000 L plastic tank is used as a peaking tank.

*Figure 23: The site of the CAPS well and peaking tank.*

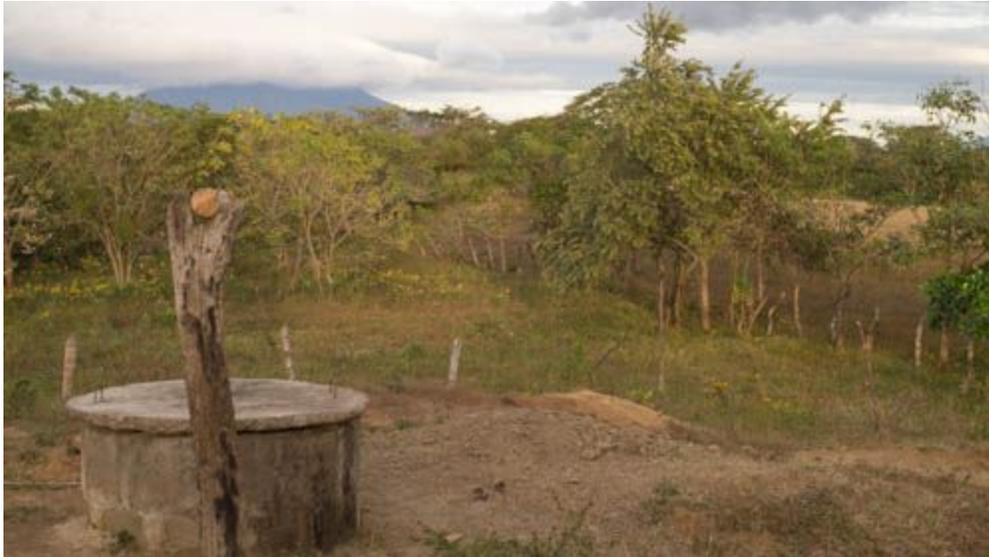
*Figure 21: The CAPS well finished and covered by Fundacion Cristianos Nicaraguenses por los Pobres.*

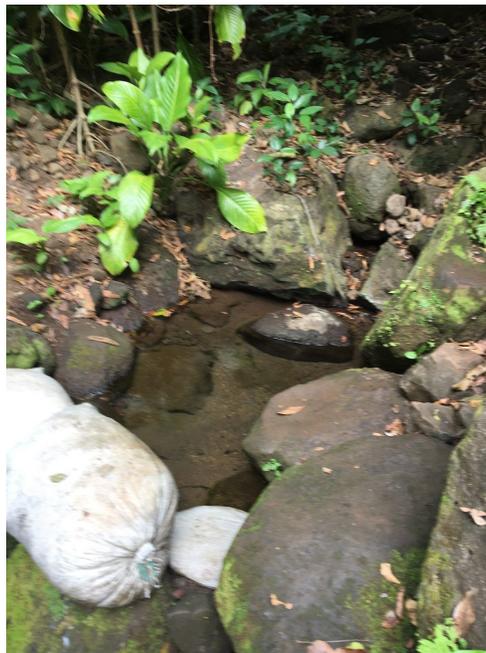
*Figure 22: The area of the stream where the clean spring comes out from the rock.*

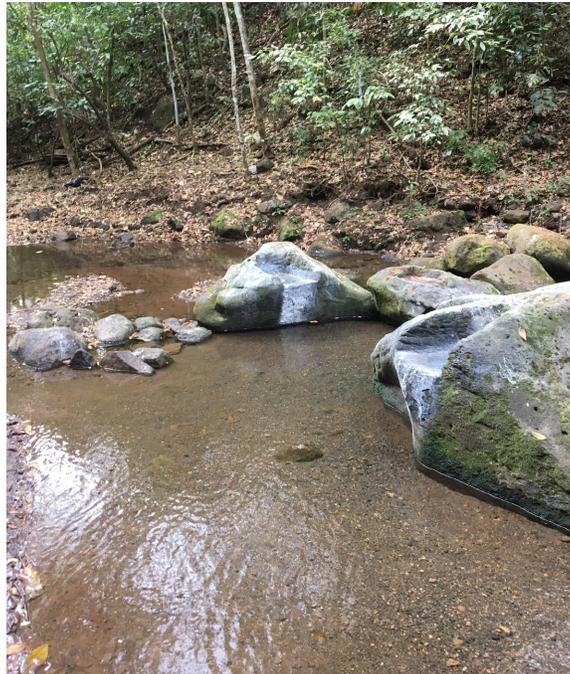
*Figure 23: The area downstream of the spring that is used for washing in the community.*

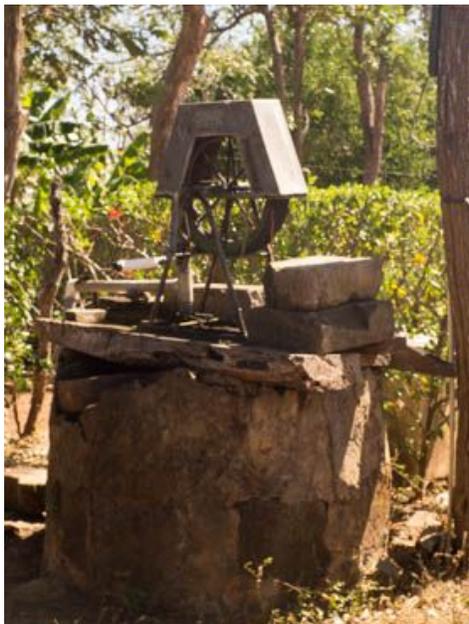
*Figure 24: A private well on the southern end of the community that has fallen into slight disrepair. Our on-site tests confirmed the presence of coliform in the well, which the households had already stopped using as a source of drinking water because it had made them ill.*

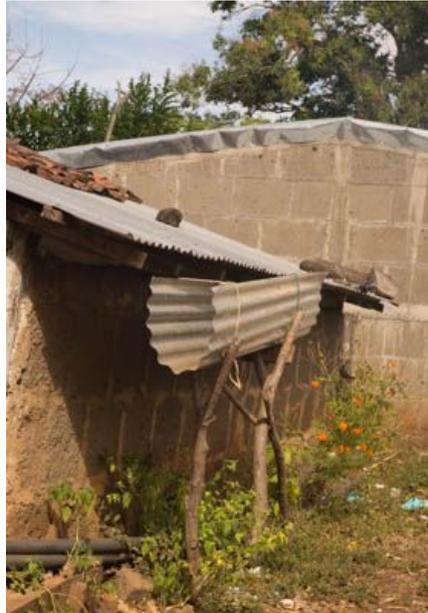
*Figure 25: An example of the method of roof rainwater collection in substitute of plastic gutters.*

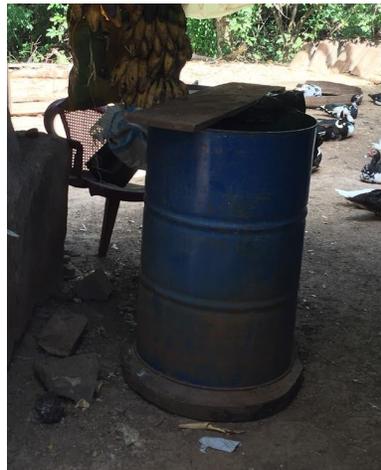
*Figure 26: A plastic 50-gallon storage container that can be used to hold rainwater.*

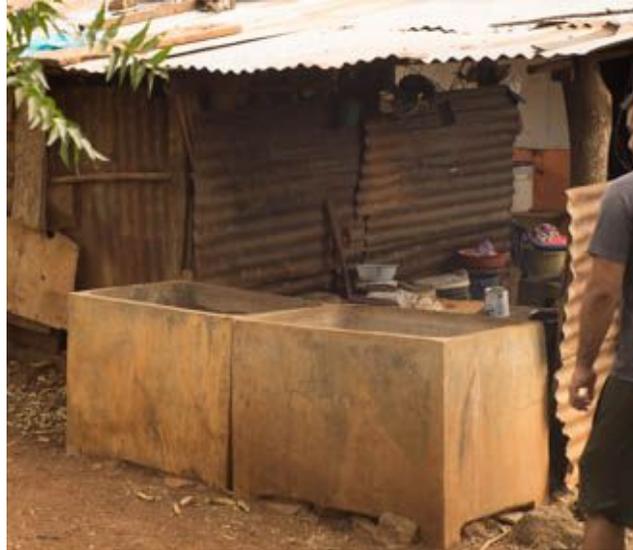
*Figure 27: Another example of the storage containers used to store rainwater or other rain sources.*

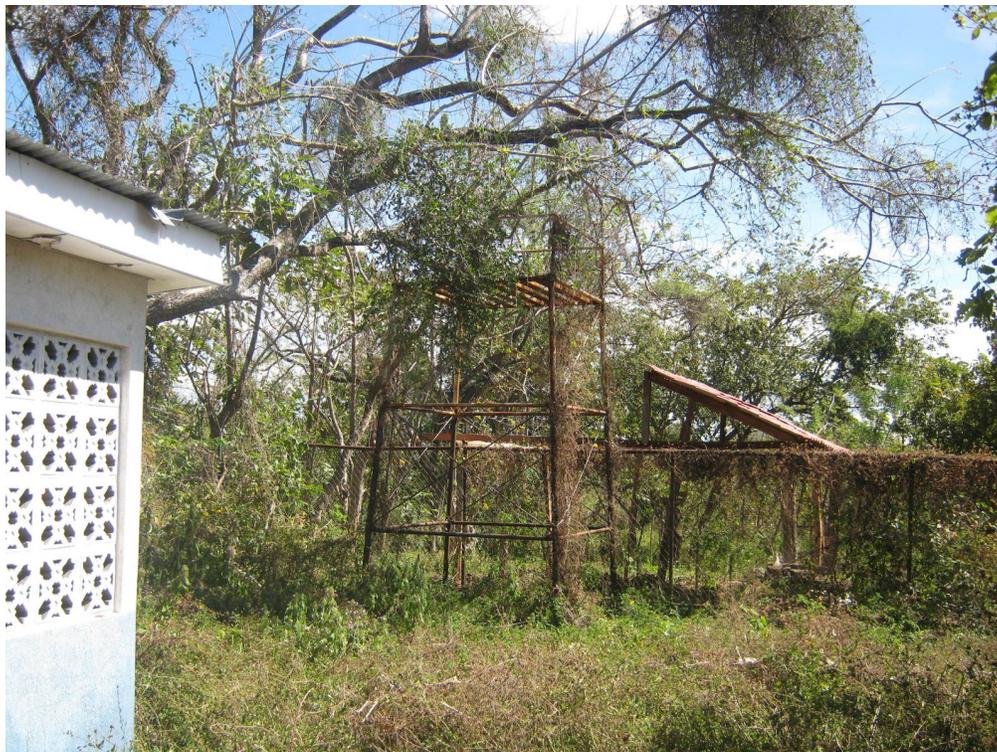
*Figure 28: The site of the tower where the old peaking tank for the school well built by the US Southern command used to rest.*

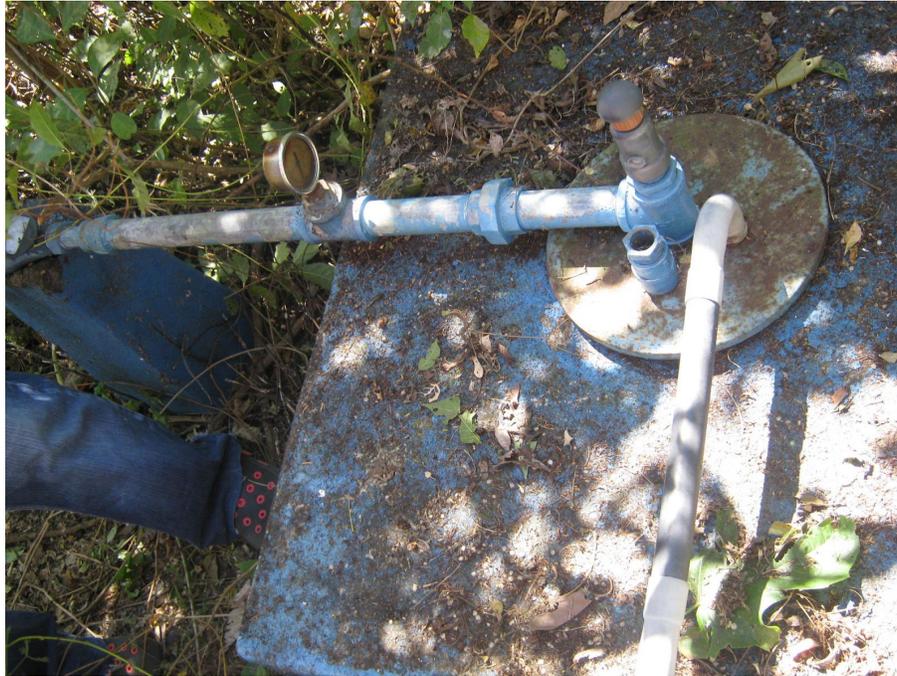
*Figure 29: The features of the current above-ground water system at the El Cacao school that used to function with the well.*

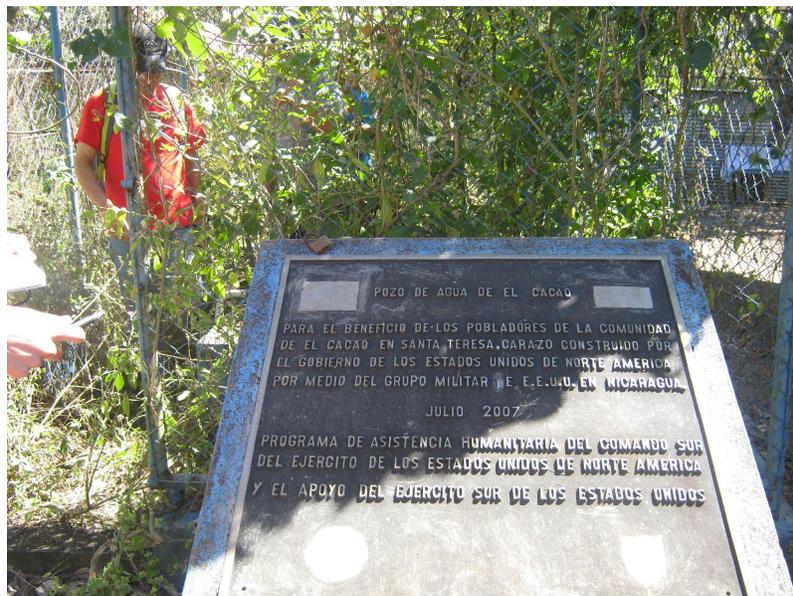
*Figure 30: The plaque from US Southern command to denote the building of the well. Behind the plaque is the cage which contains the above-ground water system in Figure 29.*

Another organization the team met with was the Ministry of Education, the group who oversees the school in El Cacao and the well that is there. The well was put in by the Southern Reserve from the United States. The well was solar powered, but was decommissioned several years ago after the panels and battery were either tampered with or stolen. Despite this, the community suggested that the well could be renovated and used as a source. To get permission, three team members met with the principal of the school Leonardo, who was incredibly willing to help out. He gave us permission to use the school well for the entire community, whereas before it was only for school use.
